WHAKARONGO SCHOOL and COMMUNITY HALL

SEWAGE SYSTEM EVALUATION & UPGRADE

Author: Dave Miller – Registered Designer

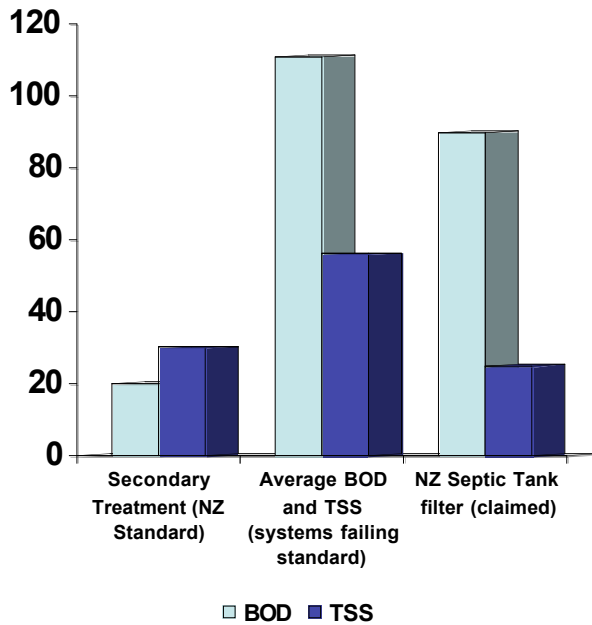
Council Tests of Secondary Treatment Systems in Hawke's Bay

- Only 17% produce secondary treated effluent
- Average of the 83% failed systems was worse than a filtered septic tank
- Not suitable for dripline

Test result data distributed at the SOS meeting in January 2004 (6) revealed that only 17% of the 58 systems tested actually produced secondary treated effluent with respect to BOD5.

Of the systems failing to meet the Standard effluent BOD5 quality (83% of those tested), the average BOD5 test result was 111g/m³. (7). For comparison purposes promotional material from a New Zealand septic tank effluent filter manufacturer (8) claims their effluent filter will produce an effluent quality of BOD5 90g/m³.from a septic tank or primary chamber of their sewage treatment system.
