Waste Water NEWS - No 1: 2005/06

DON'T SPEND \$10,000+ ON A LEMON

NEW STATE OF THE ART SEWAGE SYSTEM FOR WHAKARONGO SCHOOL

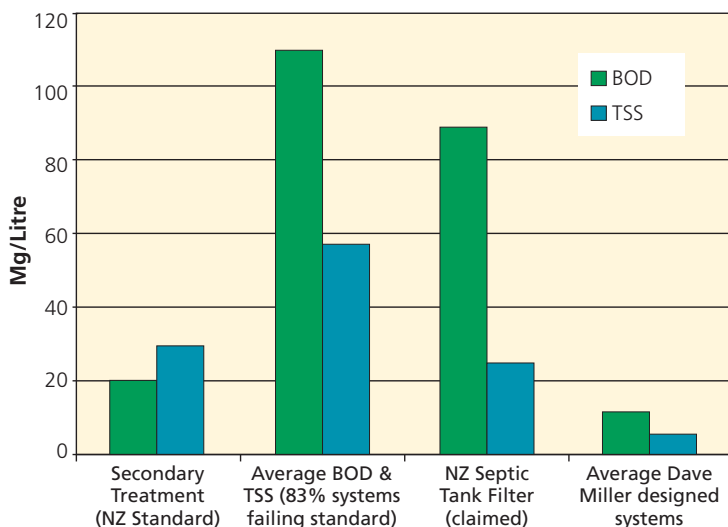
Hawkes Bay Region Sewage System Comparison {The lower the figure, the better the treatment}

Note: [BOD – Biochemical Oxygen Demand – is a measure of the amount of oxygen a pollutant sucks out of the ground (or water) in order to become treated. TSS – Total Suspended Solids – is a measure of the level of suspended matter (ie the degree of cloudiness) of the effluent. The lower the figure, the better the degree of treatment.]

If you don't want sewage problems, don't buy a cheap sewage system. Test data from the Hawkes Bay Regional Council monitoring program revealed that only 17% of secondary sewage treatment systems actually produced secondary treated effluent.

The **average** effluent quality of the systems not meeting secondary treatment levels (83% of those tested) was 5 times the allowable level and the effluent quality from many systems was no better than from a filtered septic tank. Interestingly a filtered septic tank only costs \$1500.

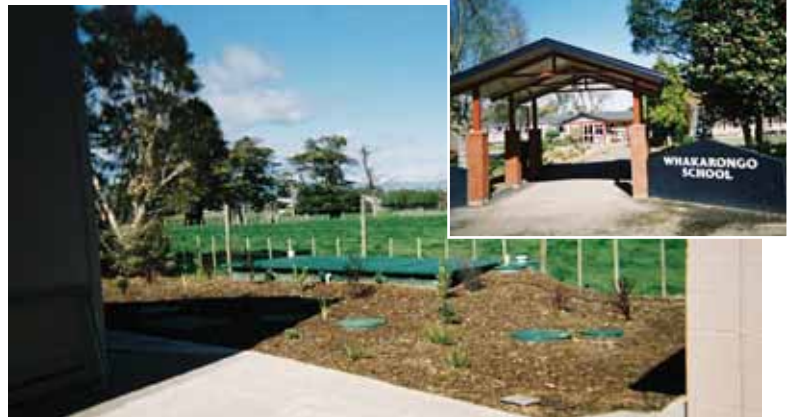
The Treatment Plant.

As the school was already pushed for land area to accommodate the hall, extra classrooms, and still provide adequate play ground facilities, Dave designed a state of the art sewage treatment system to completely treat the sewage and make it virtually harmless.

The system also has a UV sterilizing unit and an automatic internet link to enable monitoring to be done remotely which saves costs and unnecessary service visits.

In view of the high rate of failure of the treatment system processes identified in the Hawkes Bay monitoring program the design of the recirculating textile Packed Bed Reactor (rtPBR) treatment process represented the most cost effective solution and protects the school from the dangers of inadequately treated sewage.

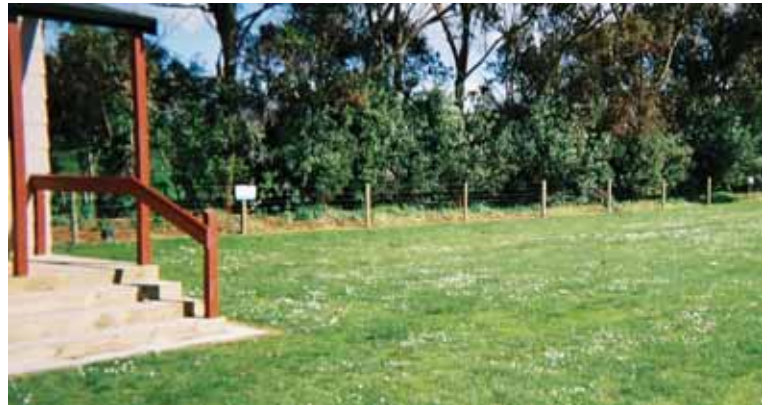
The treated effluent disposal area in shelter belt along fence line. (The effluent is treated to a quality 5 times better than required by the NZ Standards and 20 times better than the quality produced by 83% of the treatment systems tested in the Hawkes Bay Monitoring program).

The sewage is treated to a quality 5 times better than required by the NZ Standards and 20 times better than the quality produced by 83% of the treatment systems tested in the Hawkes Bay Monitoring program.
